**10031.07**  
**Balance**  
**2020 Exterior Review**

Regarding: **2020 Exterior Review**

Method Engineering and Building Services Ltd. (METHOD) was retained by Strata Plan VIS 6763 to complete an exterior review of the buildings located at 373 & 379 Tyee Road in Victoria, BC. These residential high-rise buildings, which are apart of the complex known as the Balance, were reviewed to assess the condition of certain building envelope components and indicate repair/renewal needs.

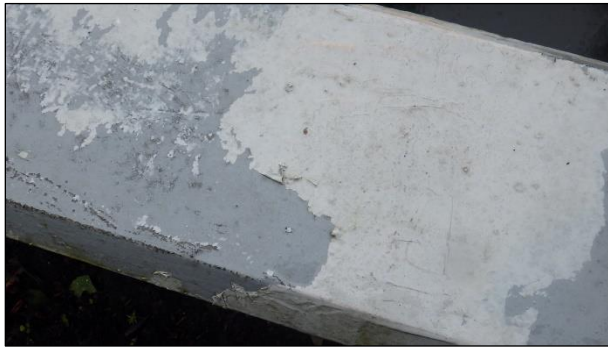
- ♦ Failure of liquid-applied waterproofing.
- ♦ Discontinuous mass concrete wall paint finish.
- ♦ Hairline cracking of concrete at floor line cold-joints.
- ♦ Damaged panel cladding. Various cladding fasteners are missing or stripped.

Figure 1 – Failure of liquid urethane waterproofing on the top surfaces of the parapet above the garden suites.

- ◆ Application of new urethane waterproofing on the top of the parapets along the green roof/podium above the garden suites (Figure 13).
- ◆ Application of new paint to the vertical surface of the parapets along the green roof/podium above the garden suites (Figure 13).
- ◆ Repairs and repainting of the eyebrow soffit finish above garden suites.
- ◆ Localized repairs to areas of urethane waterproofing at noted balcony scuppers (2 locations)
- ◆ Localized repairs to cladding at roof top (both buildings)
- ◆ Other minor tasks, such as: metal flashing repairs, rainwater leader repairs, localized sealant repairs.

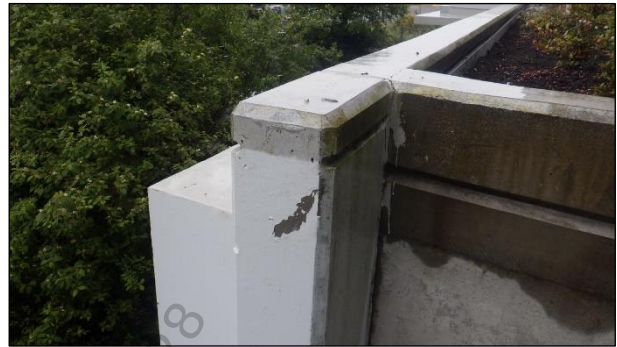
Figure 2 – Failure of wall paint at the parapet areas above the garden suites.

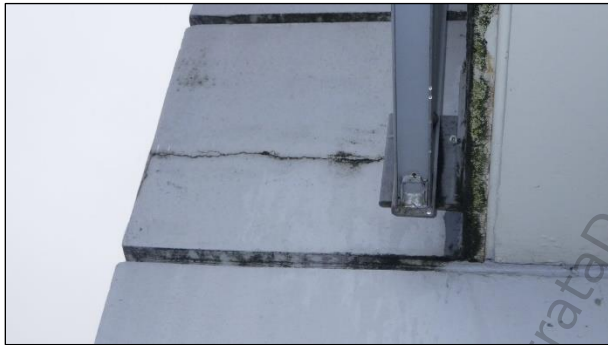
Figure 3 – Hairline cracking, which was noted near various balcony/wall saddles.

- ◆ Washing of the exterior cladding surfaces. This is most notable at the upper levels. This would likely be completed in conjunction with exterior painting. The cracking at the floor-line cold joints (Figure 3) would be addressed as part of the exterior painting. Washing of the metal cladding at the ground floor townhouse units could be completed at any time.
- ◆ Repainting or replacement of various aluminium light fixtures.

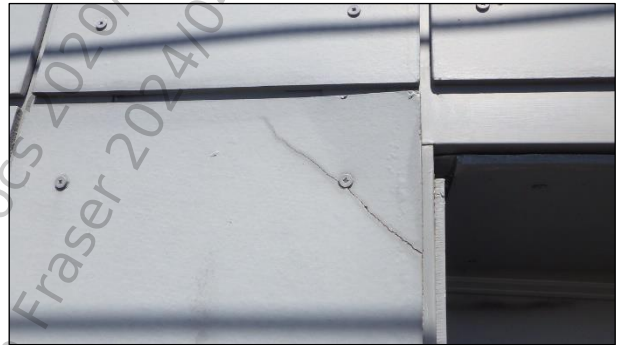
Figure 4 – Cracked panel cladding at rooftop area

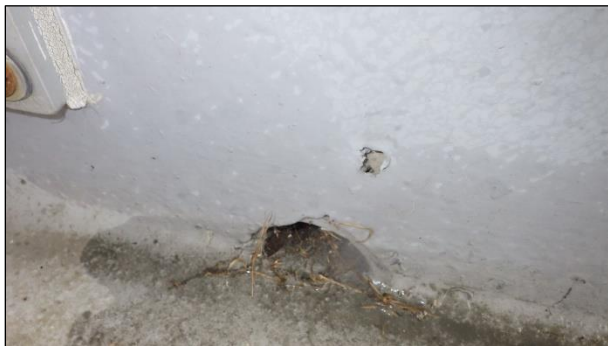
Figure 5 – Discontinuous liquid-applied waterproofing.

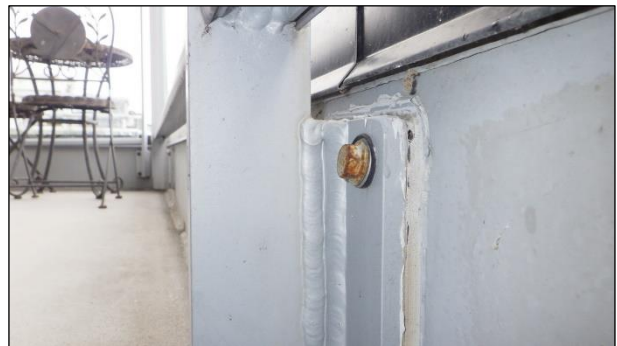
Figure 6 – Sealant failure at guardrail post bracket.

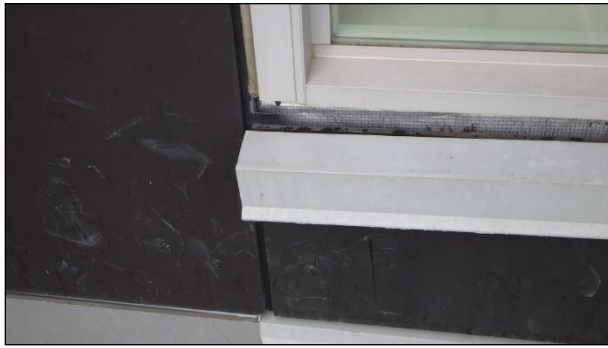
Figure 7 – Detached windowsill flashing

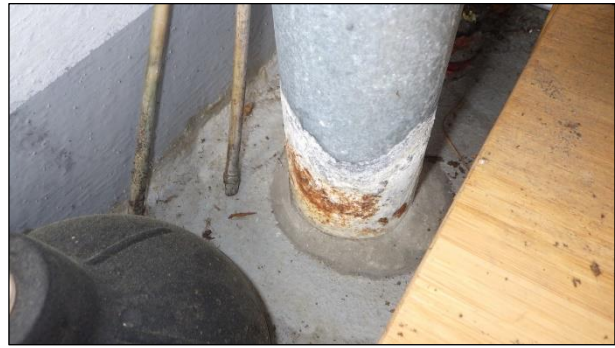
Figure 8 – Corroded metal rainwater leader.

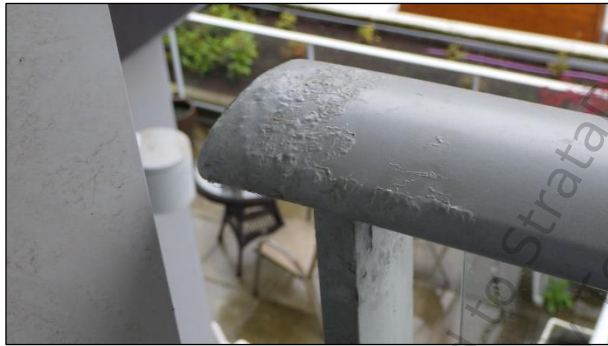
Figure 9 – Guardrail coating deterioration.

- ◆ Repainting of aluminum guardrails. This is a cosmetic need and the coating failure does not impact the structural performance of the guard rails.
- ◆ Rainwater leader replacement. The Strata has replaced rainwater leaders in select areas over the past few years.
- ◆ Monitoring of liquid urethane waterproofing conditions, specifically at eyebrows and balconies. Comprehensive renewal is not required at this time, but the Strata should plan for comprehensive renewal within 5 years. NOTE – Damage to liquid urethane waterproofing at a concrete balcony fascia was noted at one location, and similar conditions should be given special consideration as part of a comprehensive renewal. Temporary removals of guardrail components may be required to apply liquid urethane to the slab edge.

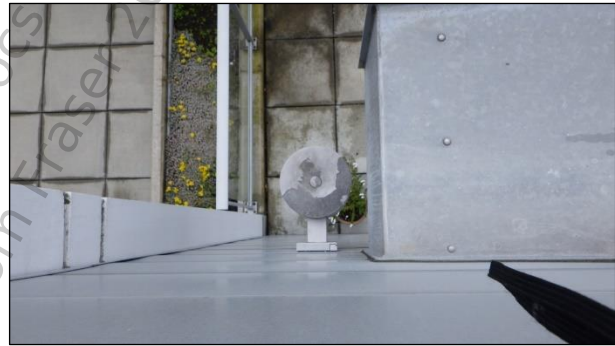
Figure 10 – Deterioration to light fixture paint finish.

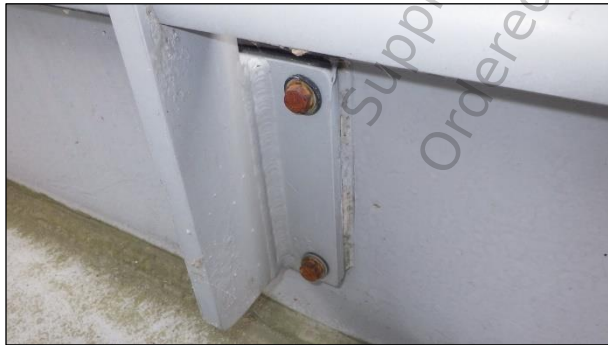
Figure 11 – Corrosion of the guardrail bolt heads. This is mainly a cosmetic issue at this time.

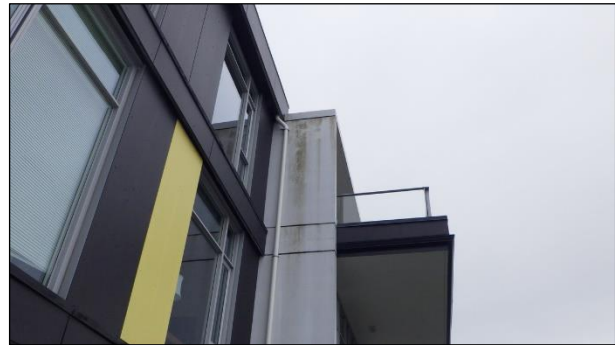
Figure 12 – Staining to wall paint finish.

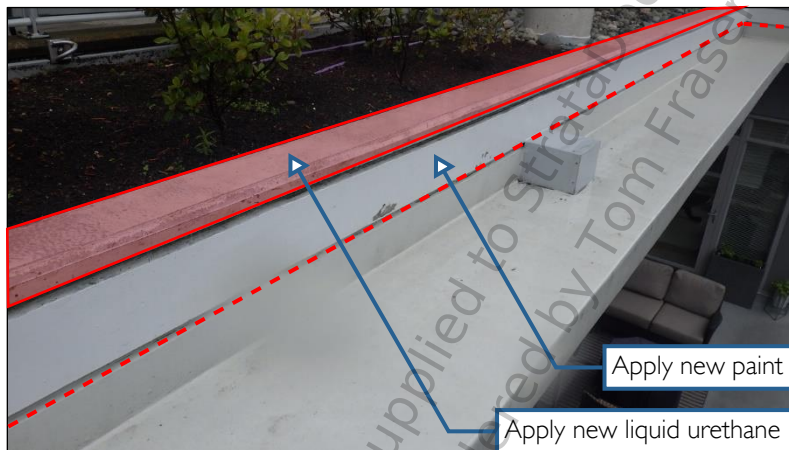
Figure 13 – Recommended parapet repairs along the green roof/podium above the garden suites.

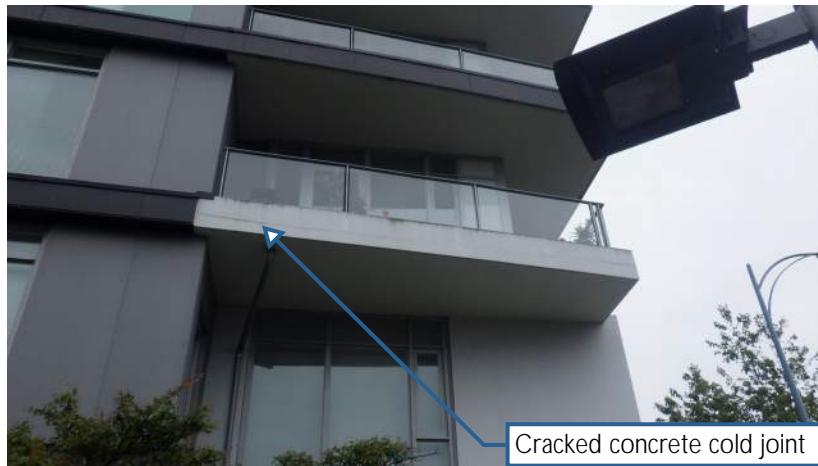
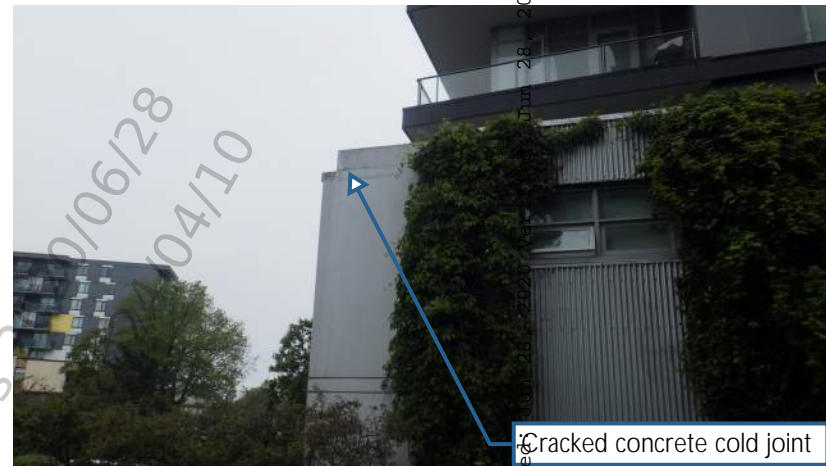
ID	PHOTOS	LOCATION	OBSERVATIONS
01	01-01 to 01-02	<ul style="list-style-type: none"> <li>◆ Concrete curb upstand at various lower level locations</li> </ul>	<ul style="list-style-type: none"> <li>◆ Cracked concrete at cold joint between the vertical curb and horizontal slab.</li> </ul>
02	02-01 to 02-04	<ul style="list-style-type: none"> <li>◆ Various</li> </ul>	<ul style="list-style-type: none"> <li>◆ Blistering/delamination of guardrail powder coating, which exposes underlying metal. Locations with more significant coating failure are beginning to corrode.</li> <li>◆ This is mainly a cosmetic issue and does not affect the structural integrity of the guards.</li> </ul> <p>NOTE – These observations were generally limited to guardrails with significant overhang protection. This suggests that corrosion is due to salt in the air, which is forming deposits on the guardrail and causing deterioration since the guardrail is not exposed to rain wetting.</p>

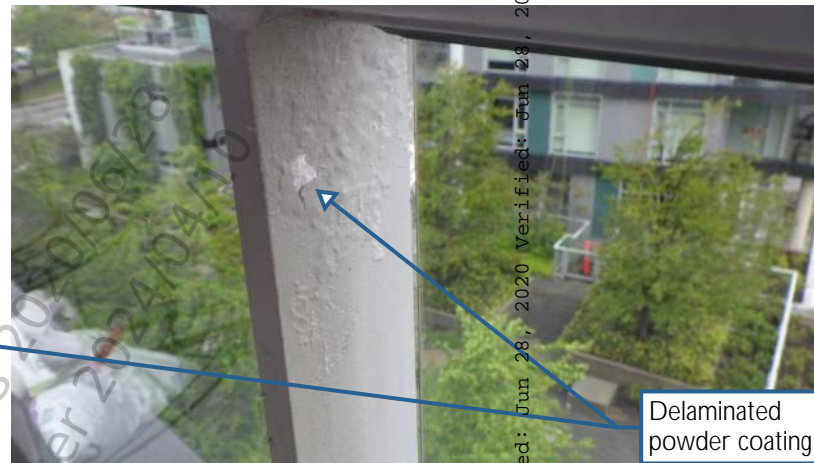
02-04

Delaminated powder coating

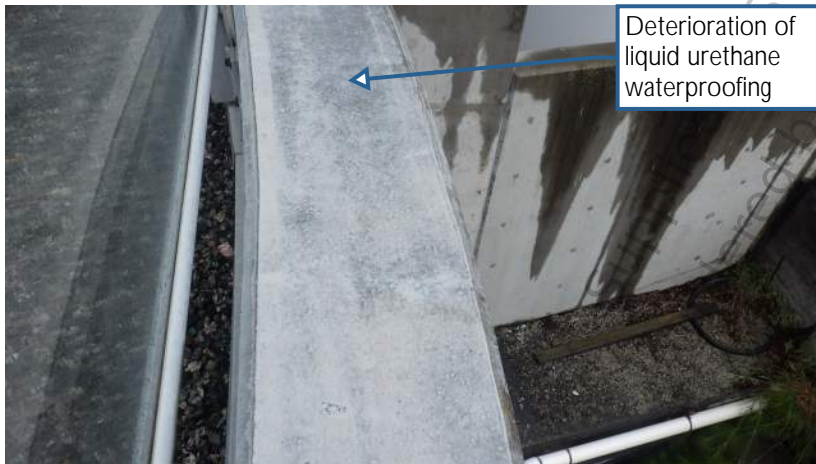
03	03-01 to 03-09	<ul style="list-style-type: none"> <li>◆ Various lower level concrete eyebrows.</li> <li>◆ Various lower level concrete eyebrows.</li> <li>◆ 373 Tyee-Roof top eyebrow</li> </ul>	<ul style="list-style-type: none"> <li>◆ Deterioration of liquid urethane waterproofing at concrete eyebrow parapets at the green roof above the garden suites. The main portion of the eyebrow was recoated last year but the top of the parapets was excluded. Specific defects to the parapet tops include: <ul style="list-style-type: none"> <li>◆ Localized areas of discolouration, which indicates accelerated levels of deterioration where the membrane application was thinner.</li> <li>◆ Flaking/delamination of membrane between coating applications.</li> </ul> </li> <li>◆ Discontinuous/missing sealant at metal box transition with concrete eyebrow waterproofing.</li> </ul>
04	04-01 to 04-04	<ul style="list-style-type: none"> <li>◆ 373 Tyee-Unit 507</li> <li>◆ 373 Tyee-Unit 701</li> <li>◆ 373 Tyee-Unit 804</li> <li>◆ 379 Tyee-Unit 709</li> </ul>	<ul style="list-style-type: none"> <li>◆ Flaking and cracking of liquid urethane waterproofing at vertical balcony curb, exposing concrete.</li> <li>◆ Scaling/debonding cant bead of sealant at vertical/horizontal balcony transition. NOTE – This was only noted at one location.</li> <li>◆ Liquid urethane damage at concrete fascia.</li> </ul>

Deterioration of liquid urethane waterproofing

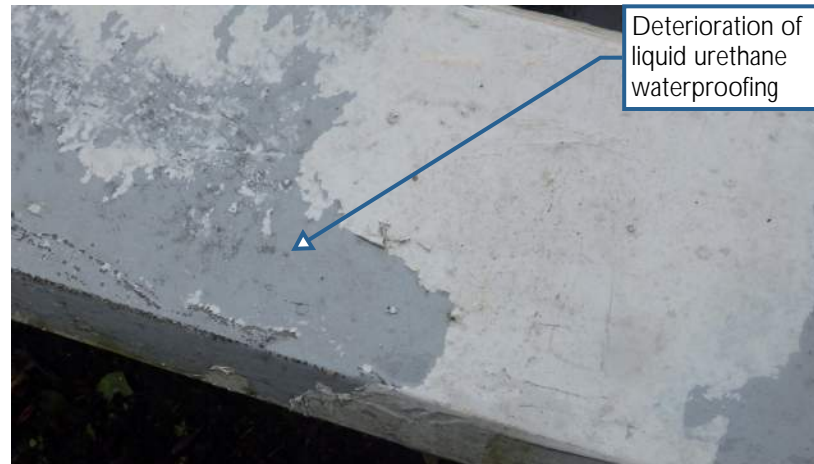
03-02

Deterioration of liquid urethane waterproofing

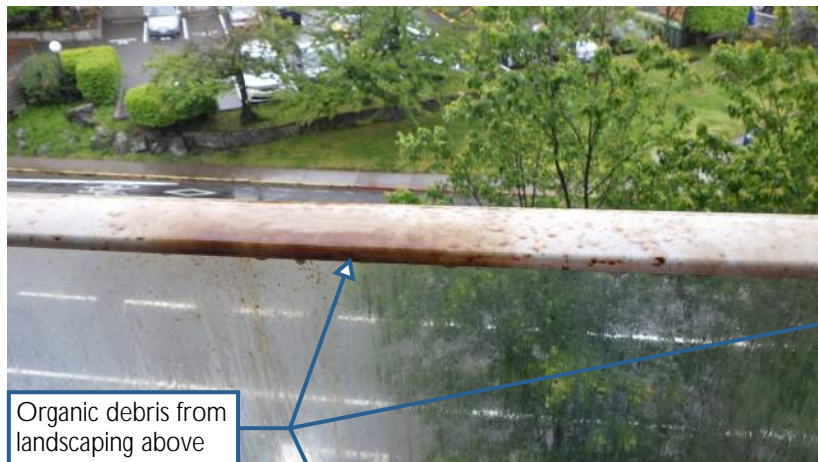
17	17-01 to 17-03	<ul style="list-style-type: none"> <li>◆ 379 Tyee – Unit 402</li> </ul>	<ul style="list-style-type: none"> <li>◆ Organic debris from landscaping at balcony above has migrated onto lower balconies from rain run-off.</li> </ul>

Organic debris from landscaping above

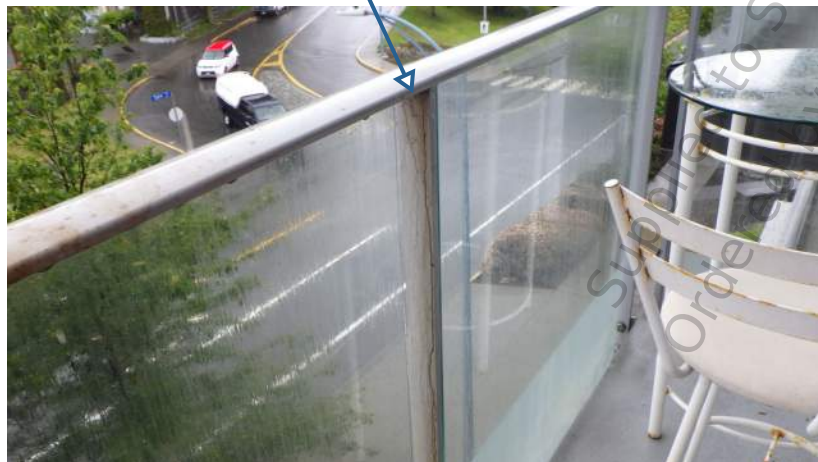
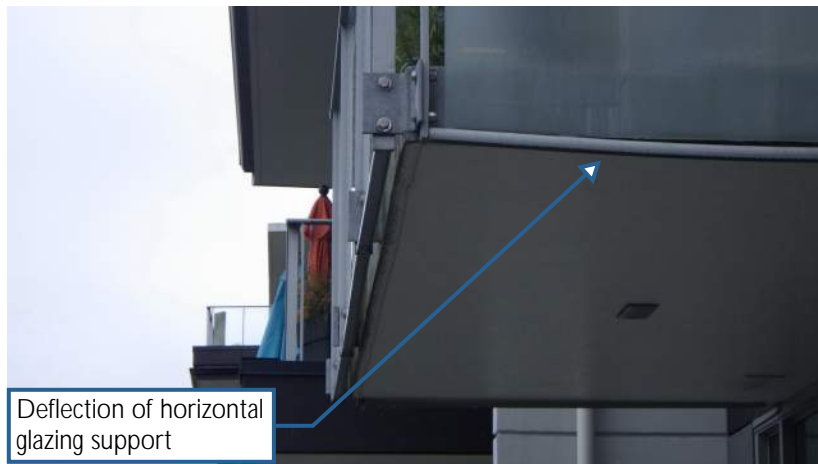
ID	PHOTOS	LOCATION	OBSERVATIONS
18	18-01 to 18-02	◆ 373 Tye – Viewed from Unit 701	◆ Deflection of horizontal glazing support. This is a visual issue and does not affect the support of the glass panel in-fill.

Deflection of horizontal glazing support
