**10031.07**  
**Balance**  
**2020 Exterior Review**

Regarding: **2020 Exterior Review**

Method Engineering and Building Services Ltd. (METHOD) was retained by Strata Plan VIS 6763 to complete an exterior review of the buildings located at 373 & 379 Tyee Road in Victoria, BC. These residential high-rise buildings, which are apart of the complex known as the Balance, were reviewed to assess the condition of certain building envelope components and indicate repair/renewal needs.

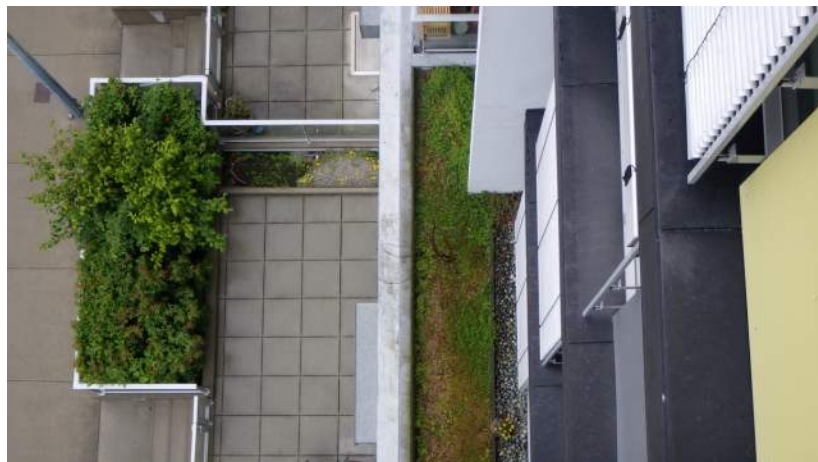
03-03

03	03-01 to 03-09	<ul style="list-style-type: none"> <li>◆ Various lower level concrete eyebrows.</li> <li>◆ Various lower level concrete eyebrows.</li> <li>◆ 373 Tyee-Roof top eyebrow</li> </ul>	<ul style="list-style-type: none"> <li>◆ Deterioration of liquid urethane waterproofing at concrete eyebrow parapets at the green roof above the garden suites. The main portion of the eyebrow was recoated last year but the top of the parapets was excluded. Specific defects to the parapet tops include: <ul style="list-style-type: none"> <li>◆ Localized areas of discolouration, which indicates accelerated levels of deterioration where the membrane application was thinner.</li> <li>◆ Flaking/delamination of membrane between coating applications.</li> </ul> </li> <li>◆ Discontinuous/missing sealant at metal box transition with concrete eyebrow waterproofing.</li> </ul>
04	04-01 to 04-04	<ul style="list-style-type: none"> <li>◆ 373 Tyee-Unit 507</li> <li>◆ 373 Tyee-Unit 701</li> <li>◆ 373 Tyee-Unit 804</li> <li>◆ 379 Tyee-Unit 709</li> </ul>	<ul style="list-style-type: none"> <li>◆ Flaking and cracking of liquid urethane waterproofing at vertical balcony curb, exposing concrete.</li> <li>◆ Scaling/debonding cant bead of sealant at vertical/horizontal balcony transition. NOTE – This was only noted at one location.</li> <li>◆ Liquid urethane damage at concrete fascia.</li> </ul>

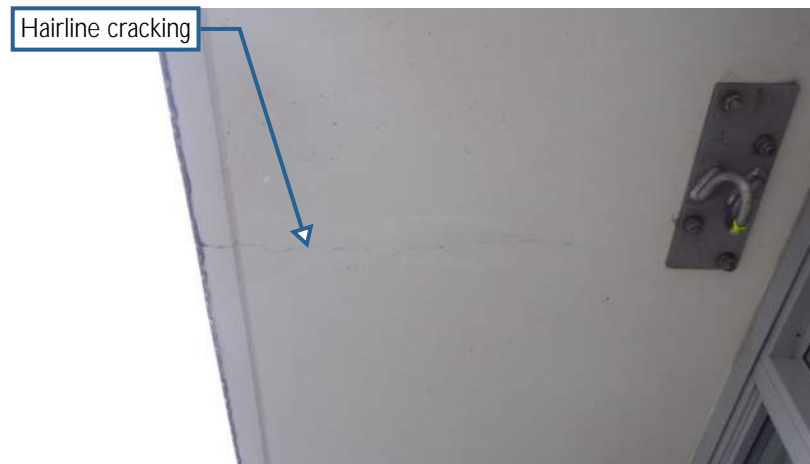
05	05-01 to 05-10	<ul style="list-style-type: none"> <li>◆ Various</li> </ul>	<ul style="list-style-type: none"> <li>◆ Hairline cracking at the underside of concrete eyebrows and similar overhangs.</li> <li>◆ Paint delamination and cracked concrete at the outside edge of balcony/roof overhang soffits</li> <li>◆ Paint blistering at eyebrow soffit due to previous water leakage. This was noted above garden level suites.</li> </ul>
06	06-01 to 06-07	<ul style="list-style-type: none"> <li>◆ Various</li> <li>◆ 373 Tyee-Unit 804</li> </ul>	<ul style="list-style-type: none"> <li>◆ Hairline cracking to concrete wall. NOTE – Cracking was common at various balcony/wall saddle locations.</li> </ul>

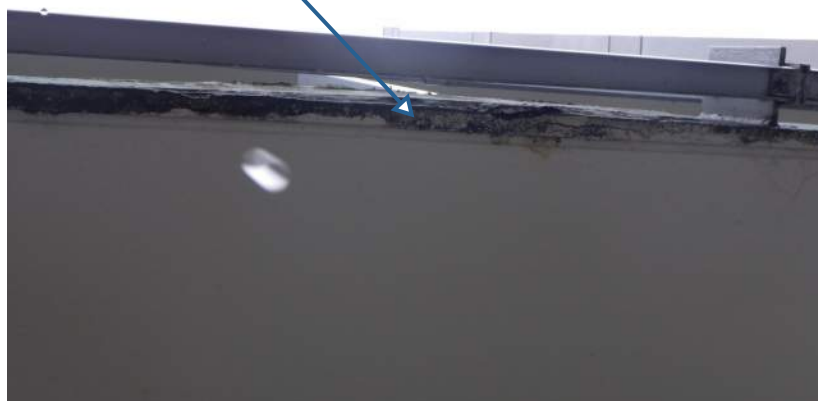
05-06

Paint delamination

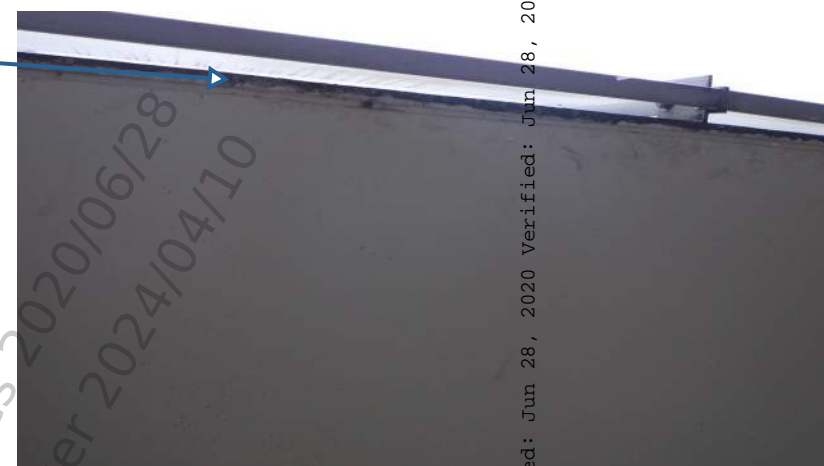
05-07

Hairline cracking

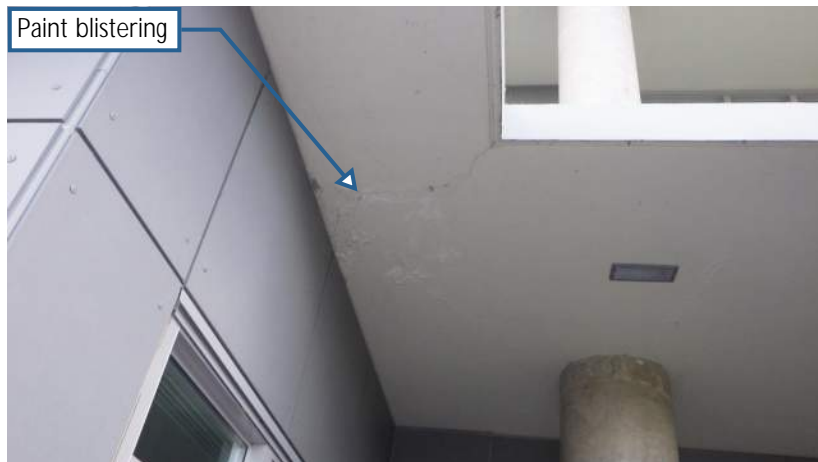
05-10

Paint blistering

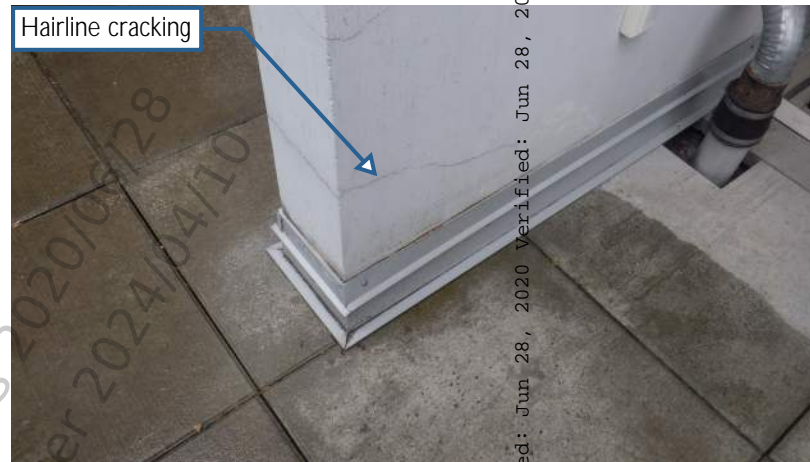
06-01

Hairline cracking

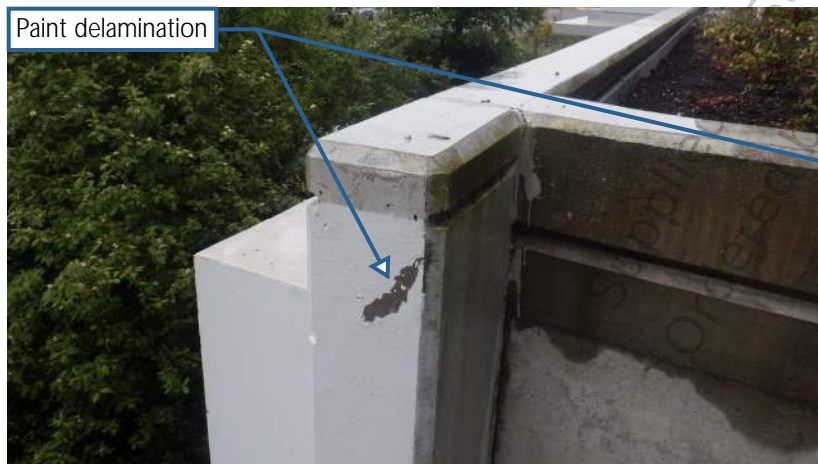
06-02

Paint delamination

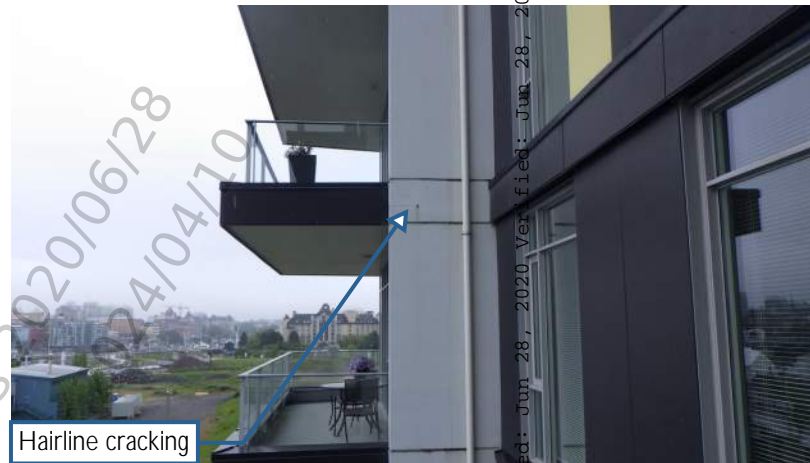
06-05

Hairline cracking

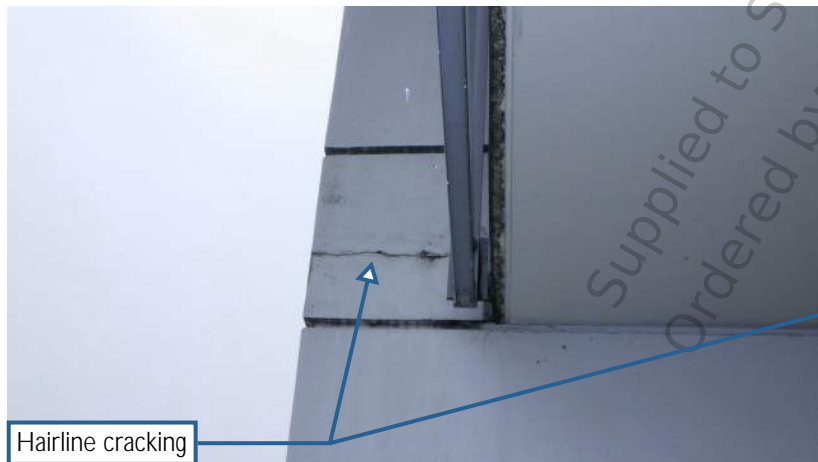
06-06

Hairline cracking

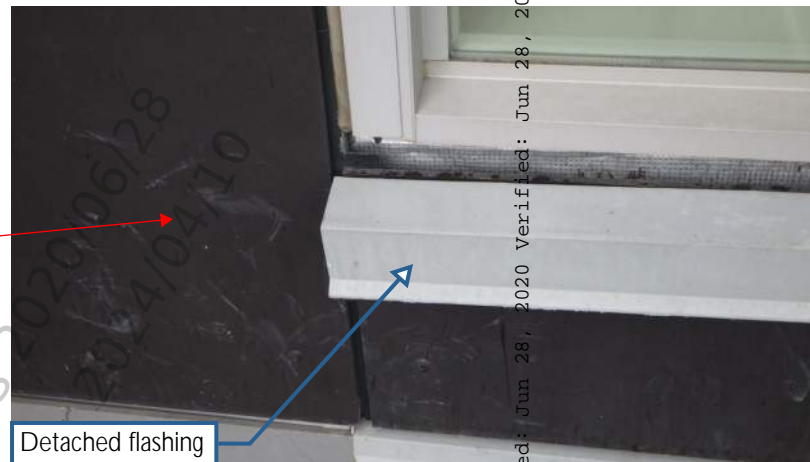
08-02

Detached flashing

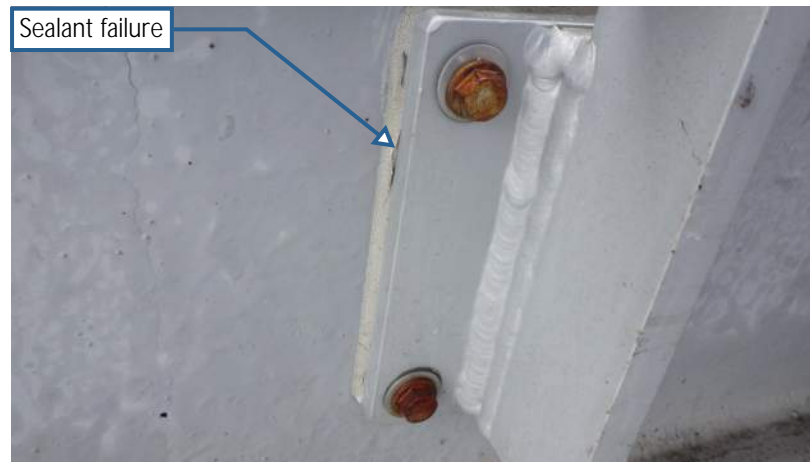
09-02

Sealant failure

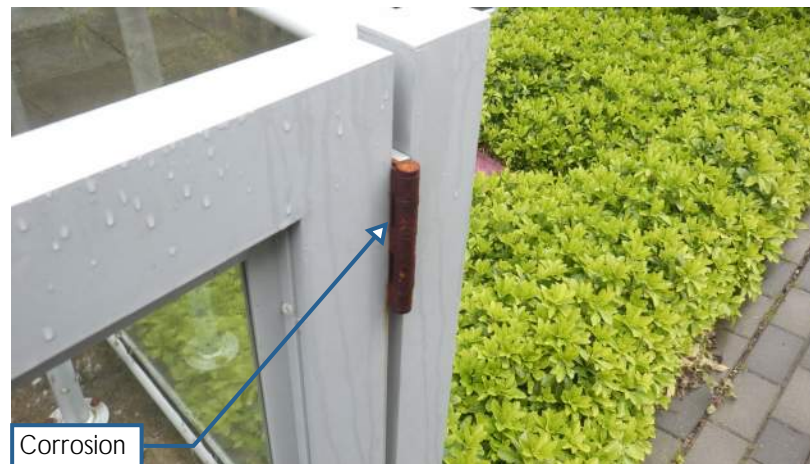
14	14-01 to 14-05	<ul style="list-style-type: none"> <li>◆ Various</li> </ul>	<ul style="list-style-type: none"> <li>◆ Corroded gate hinge.</li> <li>◆ Surface corrosion to guardrail and privacy screen post attachment fasteners.</li> <li>◆ Corrosion to exposed metal flashing fasteners</li> <li>◆ Corrosion to exposed faster at canopy wall mount.</li> </ul> <p>The corrosion is minor and does not affect the structural performance. At this time, it is mainly a cosmetic concern.</p>
15	15-01	<ul style="list-style-type: none"> <li>◆ 373 Tyee - Unit 903</li> </ul>	<ul style="list-style-type: none"> <li>◆ Damage to pre-finished metal cap flashing, causing corrosion at exposed, raw, metal.</li> </ul>
16	16-01 to 16-03	<ul style="list-style-type: none"> <li>◆ Various</li> </ul>	<ul style="list-style-type: none"> <li>◆ Staining to concrete wall paint finish</li> <li>◆ Staining to liquid urethane at vertical portion of the slab above the pond.</li> </ul>

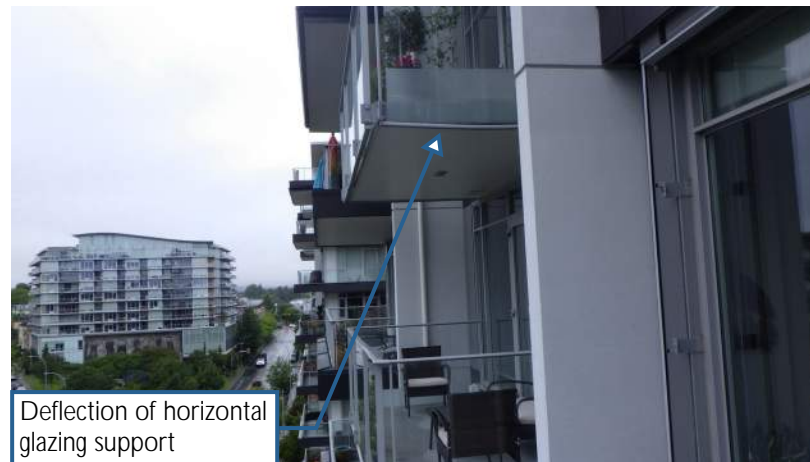
18-01

Deflection of horizontal glazing support
